1. INTRODUCTION

This report, *FEMA-351 – Recommended Seismic Evaluation and Upgrade Criteria for Existing Welded Steel Moment-Frame Buildings* has been developed by the SAC Joint Venture under contract to the Federal Emergency Management Agency (FEMA) to provide structural engineers with recommended criteria for evaluation of the probable performance of existing steel moment-frame buildings in future earthquakes and to provide a basis for updating and revision of evaluation and rehabilitation guidelines and standards. It is one of a series of companion publications addressing the issue of the seismic performance of steel moment-frame buildings. The set of companion publications includes:

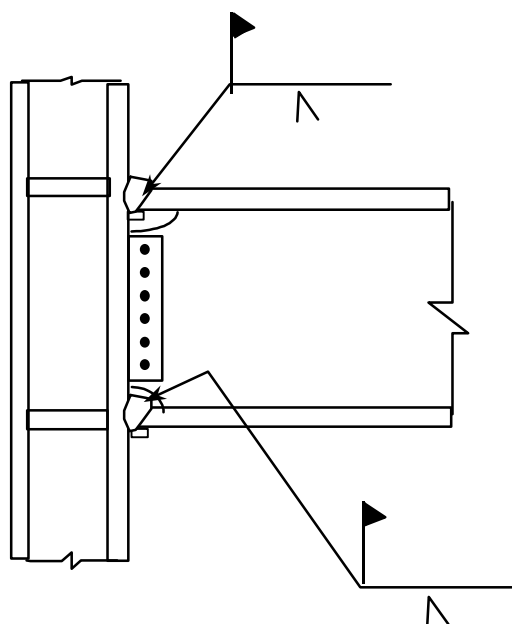
Figure 1-1 Typical Welded Moment-Resisting Connection Prior to 1994

Welded steel moment-frame buildings are anticipated to develop their ductility through the development of yielding in beam-column assemblies at the beam-column connections. This yielding may take the form of plastic hinging in the beams (or, less desirably, in the columns), plastic shear deformation in the column panel zones, or through a combination of these mechanisms. It was believed that the typical connection employed in welded steel moment-frame construction, shown in Figure 1-1, was capable of developing large plastic rotations, on the order of 0.02 radians or larger, without significant strength degradation.

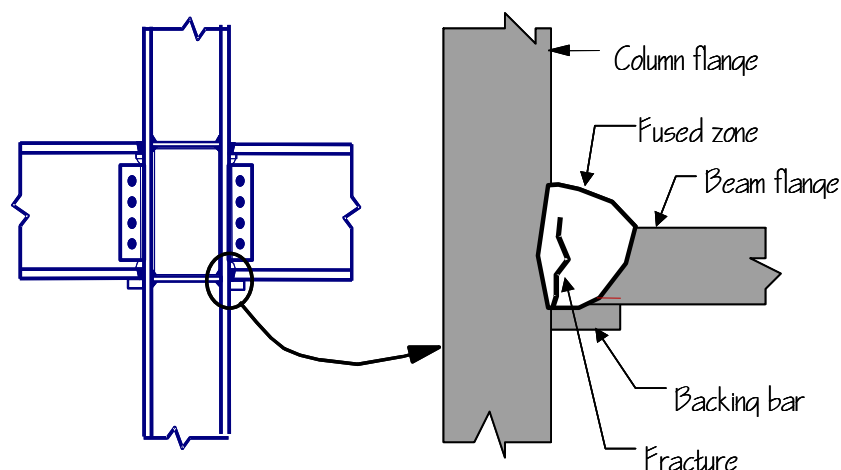
Figure 1-2 Common Zone of Fracture Initiation in Beam-Column Connection

Observation of damage sustained by buildings in the 1994 Northridge earthquake indicated that, contrary to the intended behavior, in many cases, brittle fractures initiated within the connections at very low levels of plastic demand, and in some cases, while the structures remained essentially elastic. Typically, but not always, fractures initiated at the complete joint penetration (CJP) weld between the beam bottom flange and column flange (Figure 1-2). Once initiated, these fractures progressed along a number of different paths, depending on the individual joint conditions.

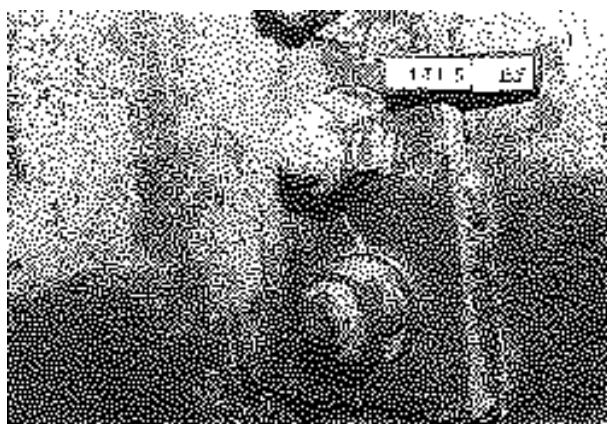
Figure 1-5 Vertical Fracture through Beam Shear Plate Connection

Once such fractures occur, the beam-column connection loses a significant portion of the flexural rigidity and strength needed to resist loads that tend to open the crack. Residual flexural strength and rigidity must be developed through a couple consisting of forces transmitted through the remaining flange connection and the web bolts. However, in providing this residual strength and stiffness, the bolted web connections can themselves be subject to failures. These include fracturing of the welds of the shear plate to the column, fracturing of supplemental welds to the

beam web or fracturing through the weak section of shear plate aligning with the bolt holes (Figure 1-5).
